Responding to Error Messages

Error Message List

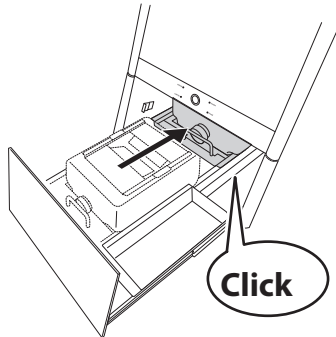
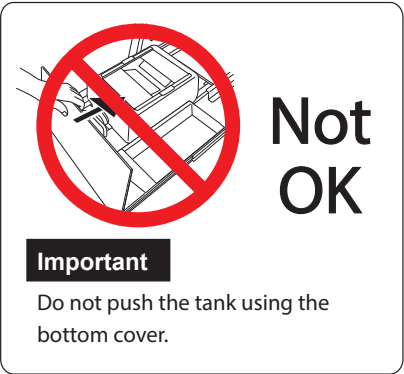
1 Install the coolant tank.

Push the coolant tank to the point where you feel a click.

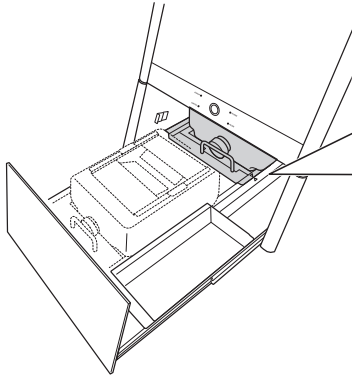
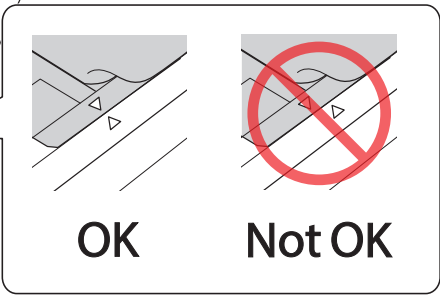
Align the ▷ label affixed to the right side of the tank with the ◁ label affixed to the machine.

Move the coolant tank slowly. Forcefully moving the coolant tank may cause the coolant to spray out.
